Combinations of Corrosion and Fatigue Failure of Wire Rope in High-Current Environments

Presented by Eric McCorquodale, BEng, EIT
Durability of Cables and Moorings in Tidal Flows
31 March 2016

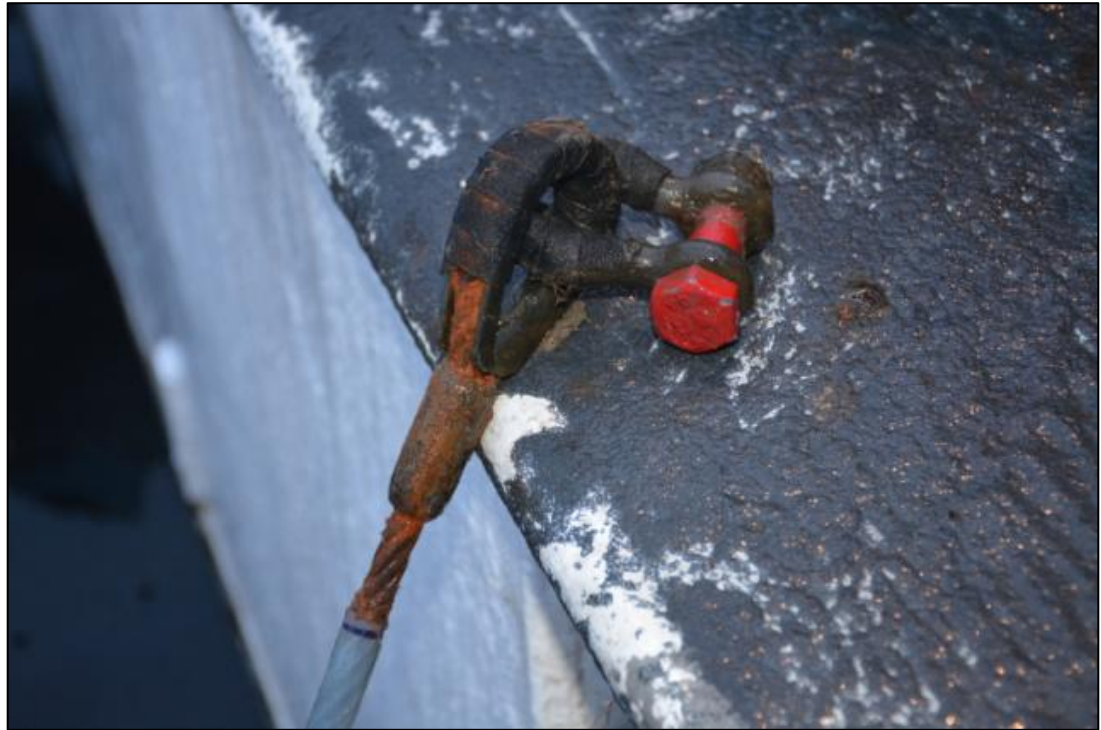
The Problem

Corrosion of Wire Rope

- Accelerated corrosion
 - Current
 - Abrasion
- Constant movement
 - Strumming
 - Fatigue
 - Torsion
 - Flexing

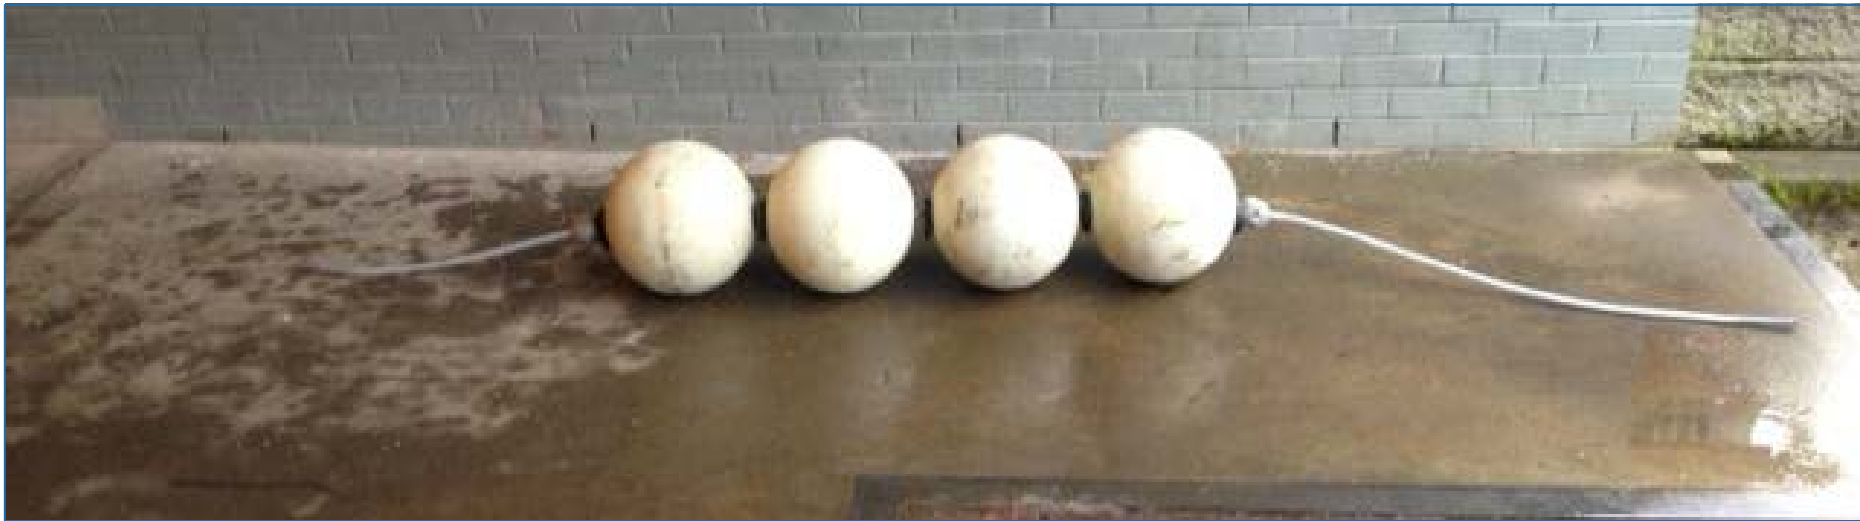
- Washed ashore

- Both ends severed

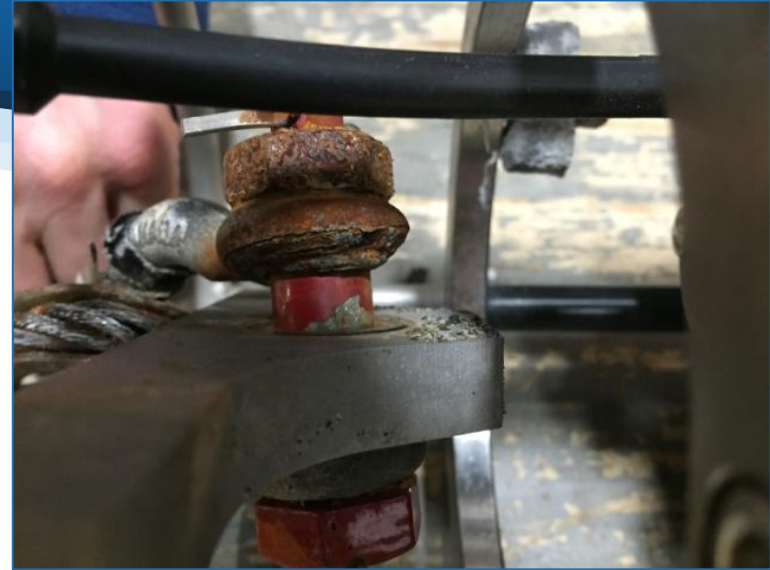
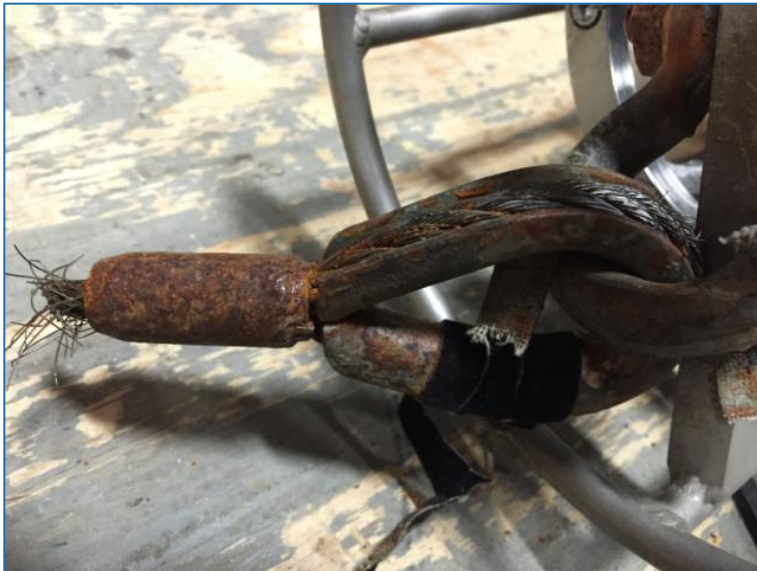
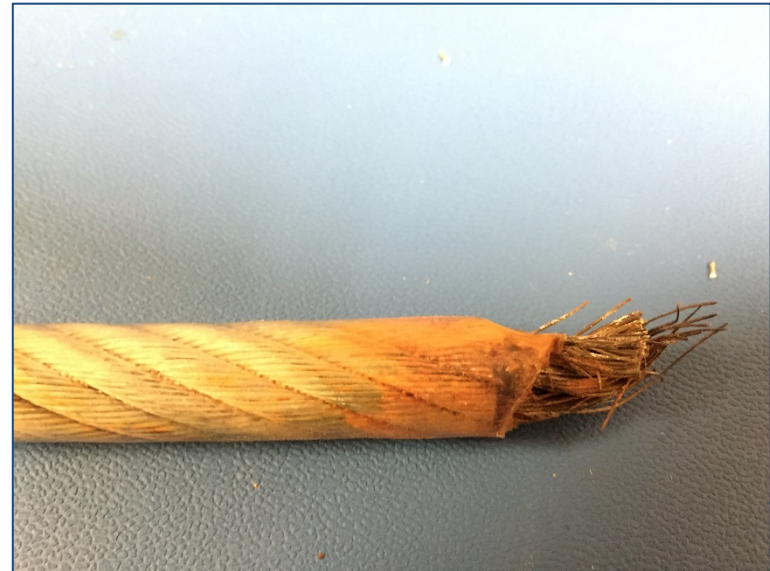
The Investigation

- No isolation
- Partial coating
- No sacrificial anodes

- Anodes
- Isolation
- Thicker strand wire
- Complete coating or no coating
- 316 SS wire
- Inhibit movement

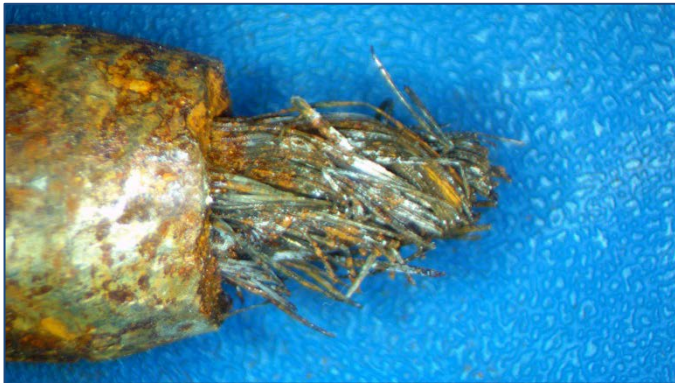
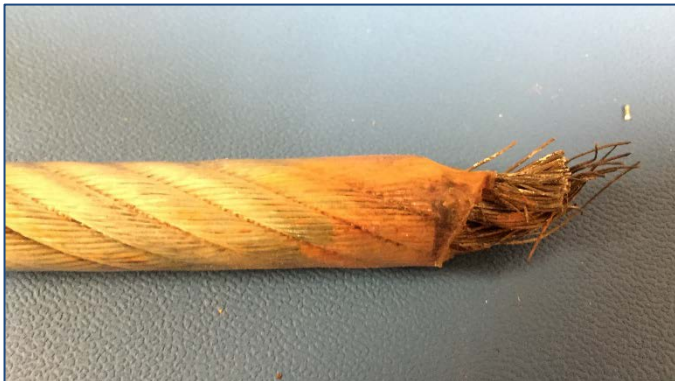
Our Break

- 40 lb load

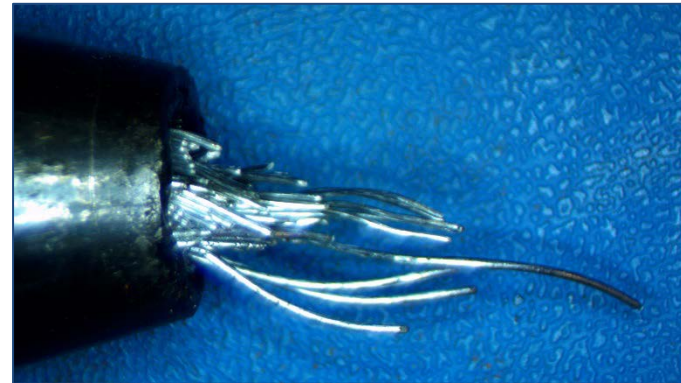
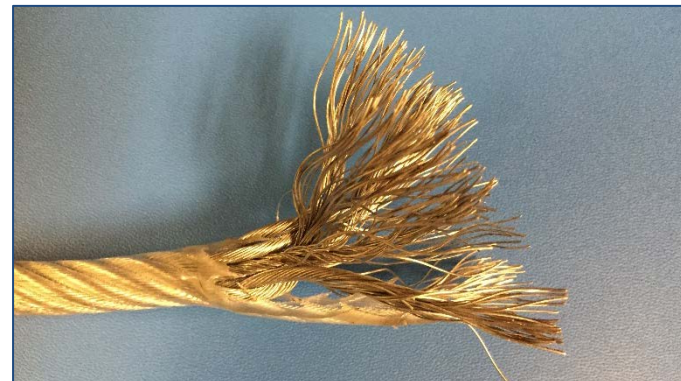
Tension break

- 18 000 lb breaking load

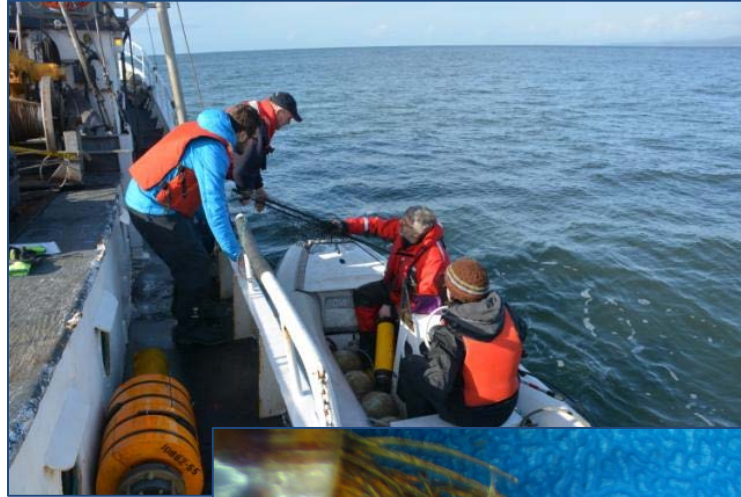
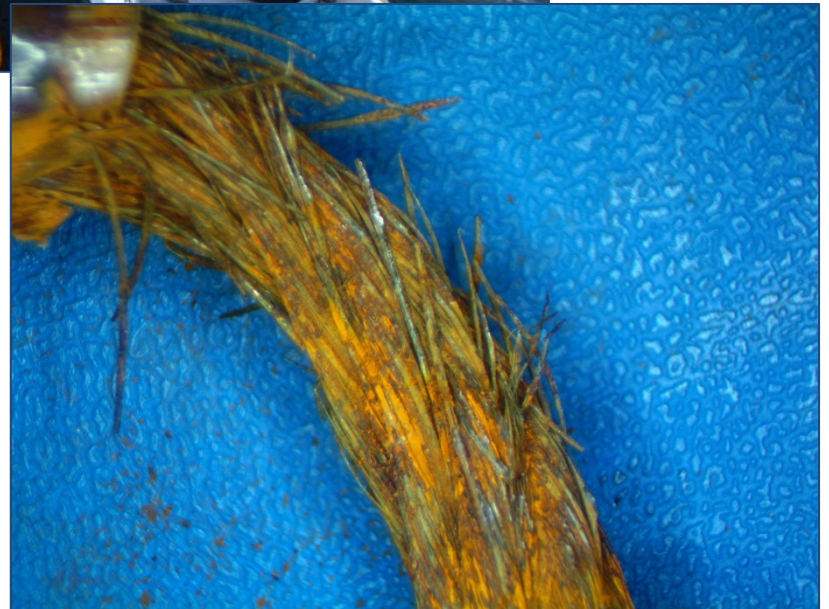
The Remaining Moorings

- 3 moorings successfully retrieved
- Floats retrieved from remaining mooring
- Recorder found on beach
- All had same problems
- Same characteristic failure mechanism

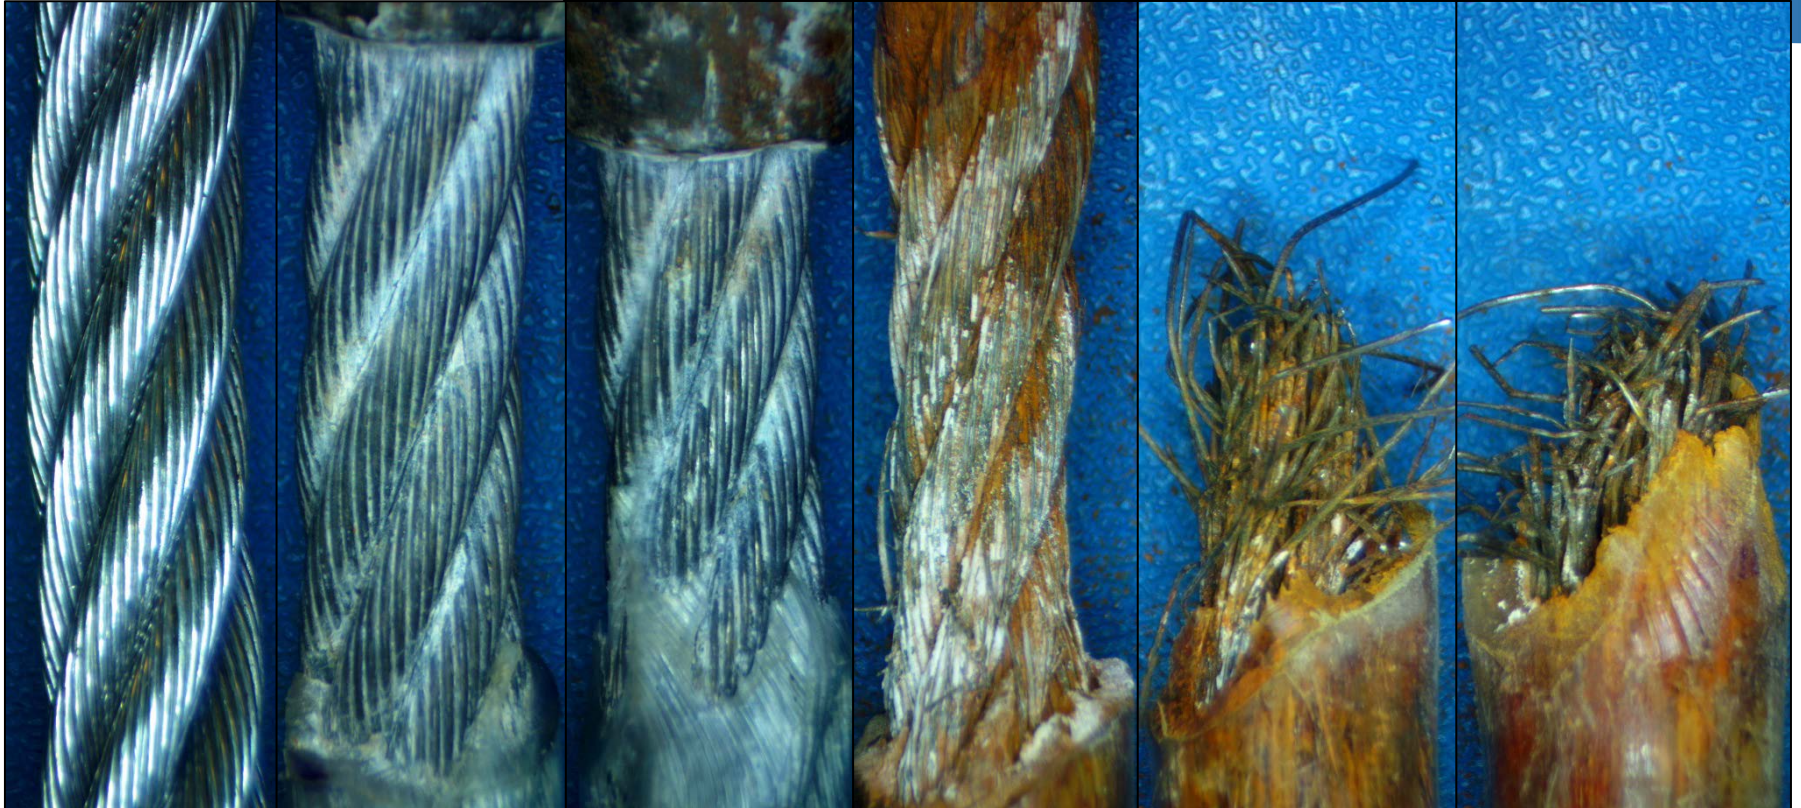
Current vs Corrosion

Increasing Current
