# Experience of Degradation of Mooring Systems used in the

# Mooring Component Failure

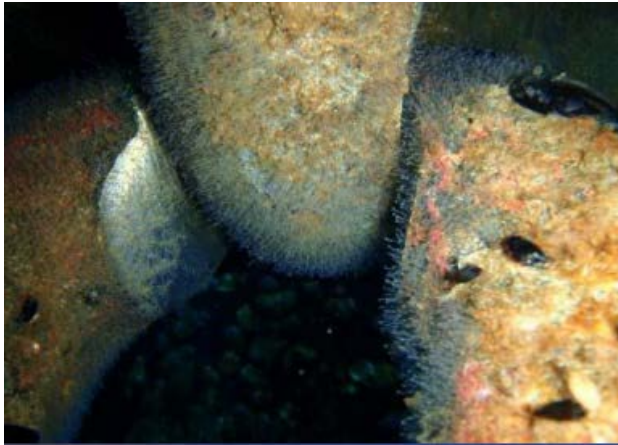
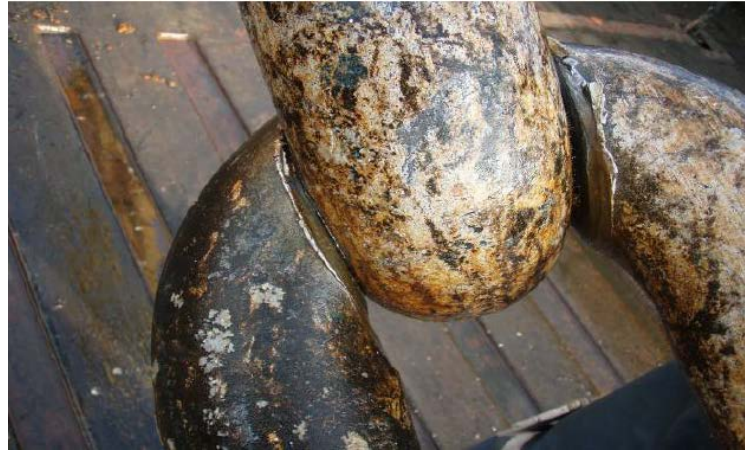
- Galvanized shackles corroded/worn prematurely.
- Obviously a combination corrosion and wear. But which is dominant?

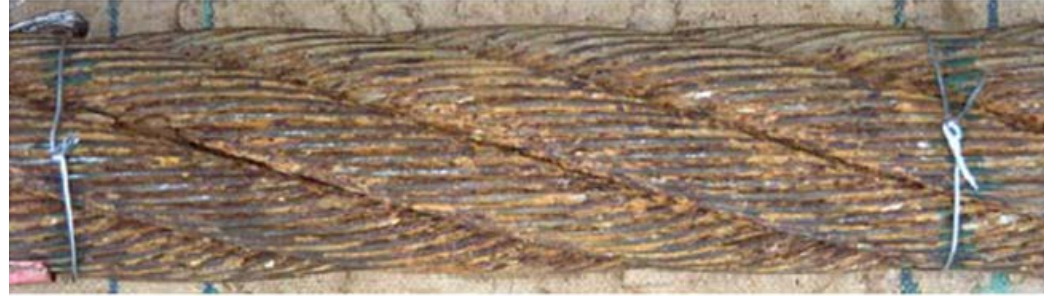
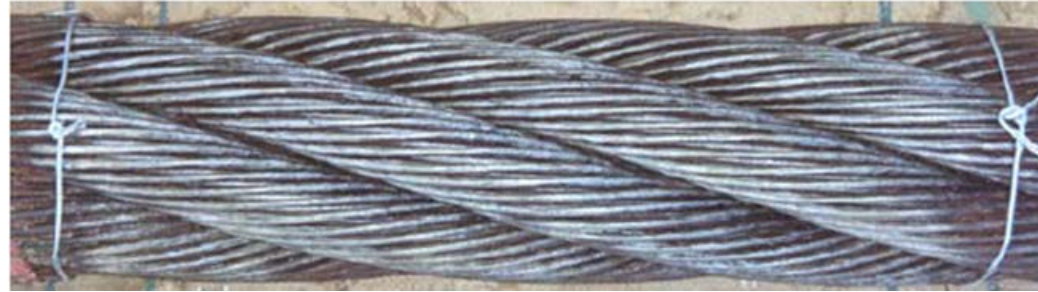
- Drilling rig wire rope after 7 years in the North Sea
- Aside from corrosion, strands appear in otherwise good condition
  - Zinc is fully consumed; steel stands freely corroding
- Wire wet sand-blasted to inspect further

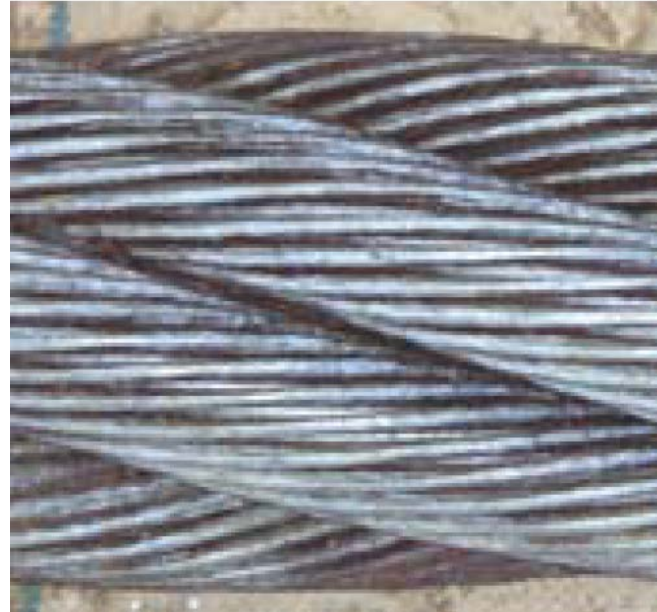
- Once the zinc is consumed, the bare wires freely corrode where zinc carbonate layer is damaged
- Corrosion is accelerated on the side of the wires in close proximity to adjacent strands
- Small movements between strands will disturb and wear away at the corrosion layer, causing further corrosion to the side of strands
- Crown of wires are not abraded and still protected by zinc-carbonate deposits
- The strands eventually appear rectangular or fin-like, forming sharp points

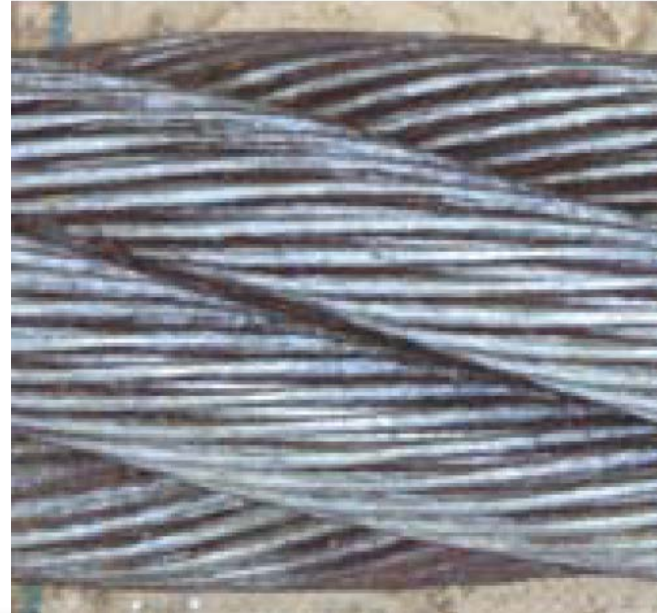
- Lower current area will improve performance of galvanizing layer and decrease the steel corrosion rate if zinc is eventually fully consumed
- Note - Armour wires in failed power cables said to have looked bright/shiny
  - Photo of wire rope (right) has been wet sand-blasted
  - Possible the entrained sand in high flow environment removes corrosion products, contributing to high corrosion rate
