Workshop: Durability of Cables and Moorings In Tidal Flows 31 March 2016

Submarine Cable Corrosion in High Current Environments

A “New” Problem?

Mike Nichols - ETA Ltd

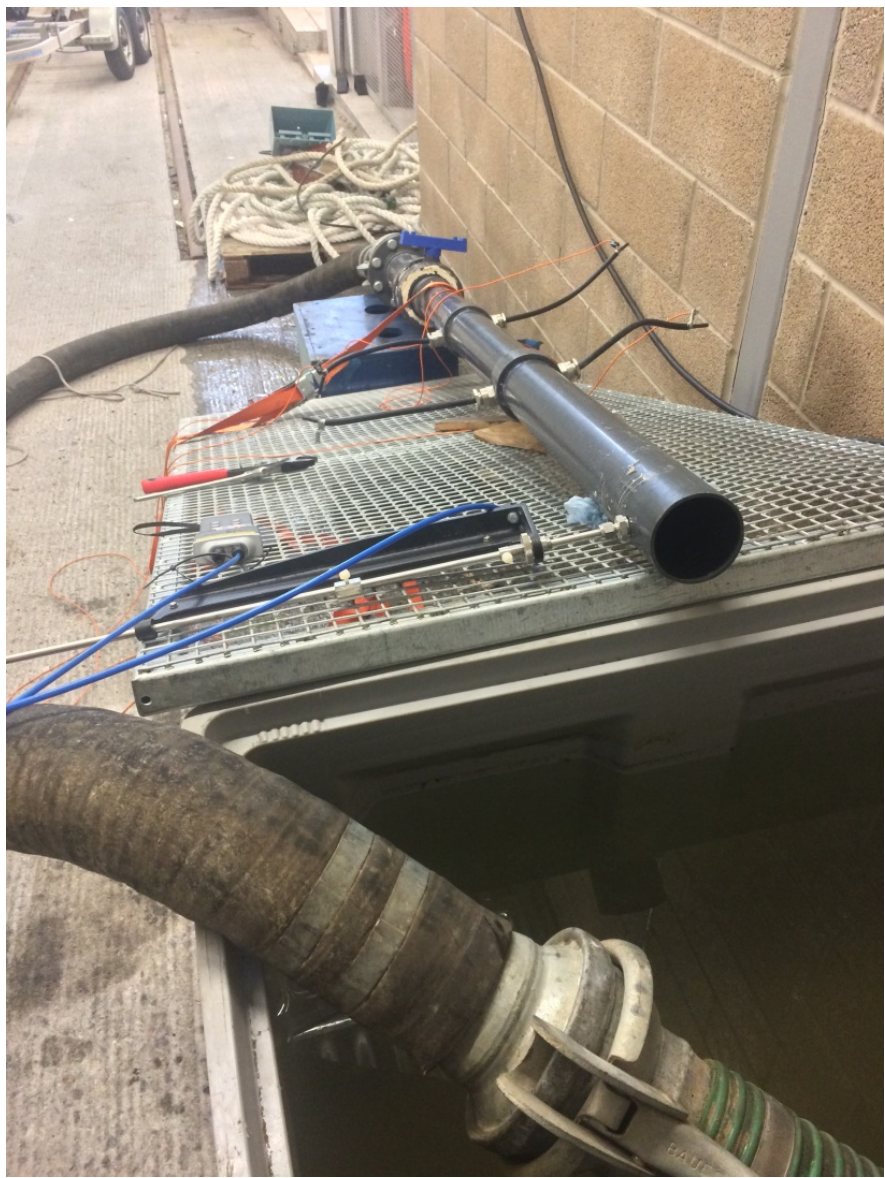
V -Experimental Set Up

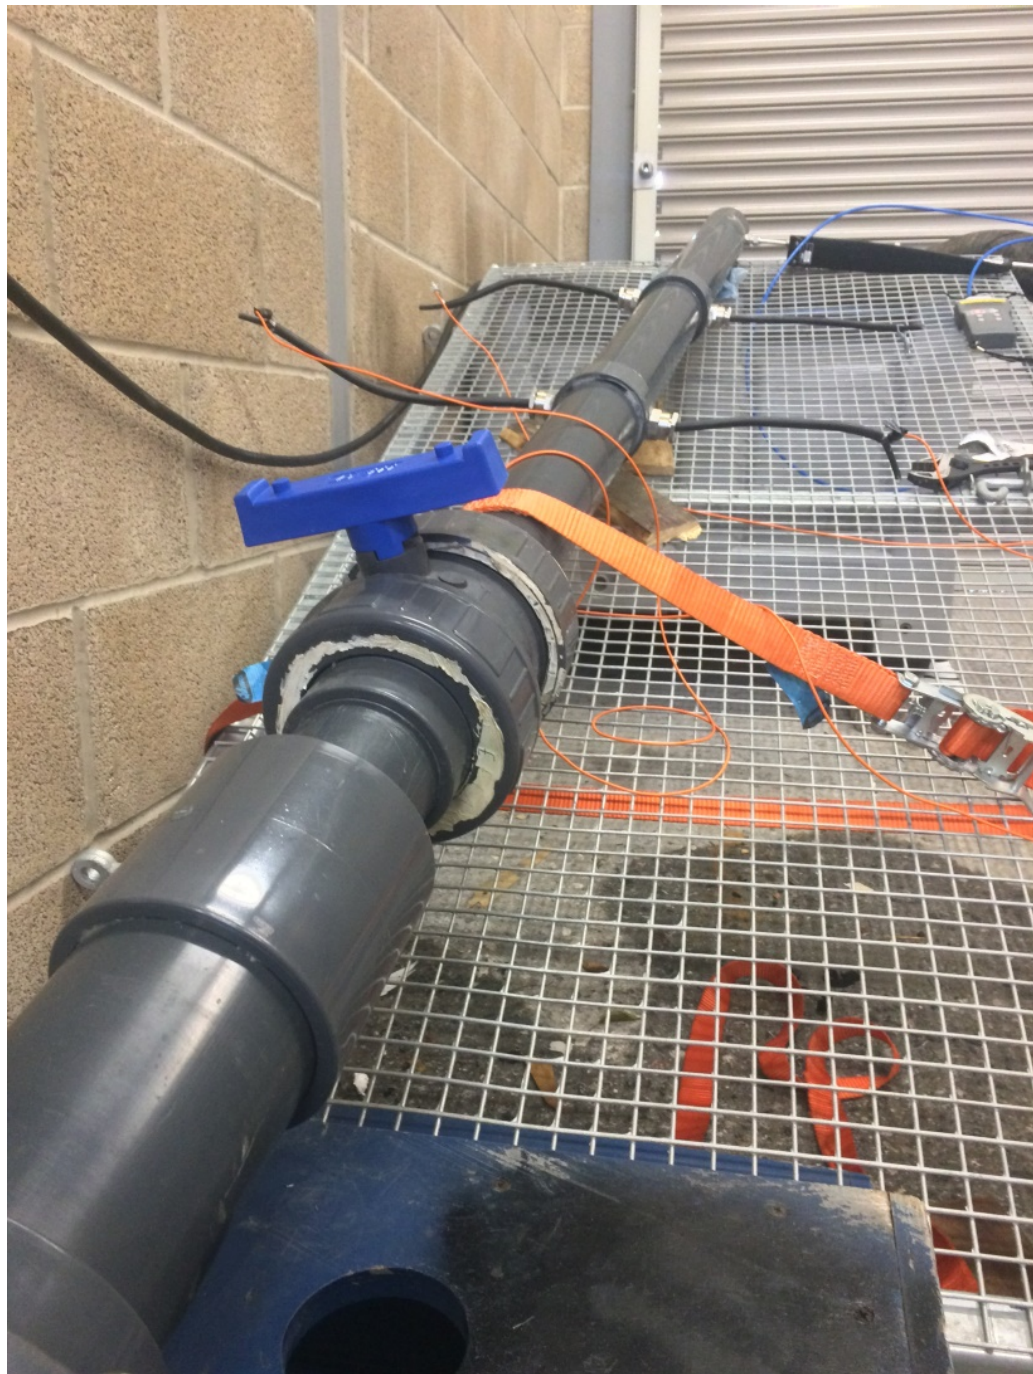
V- Experimental set up

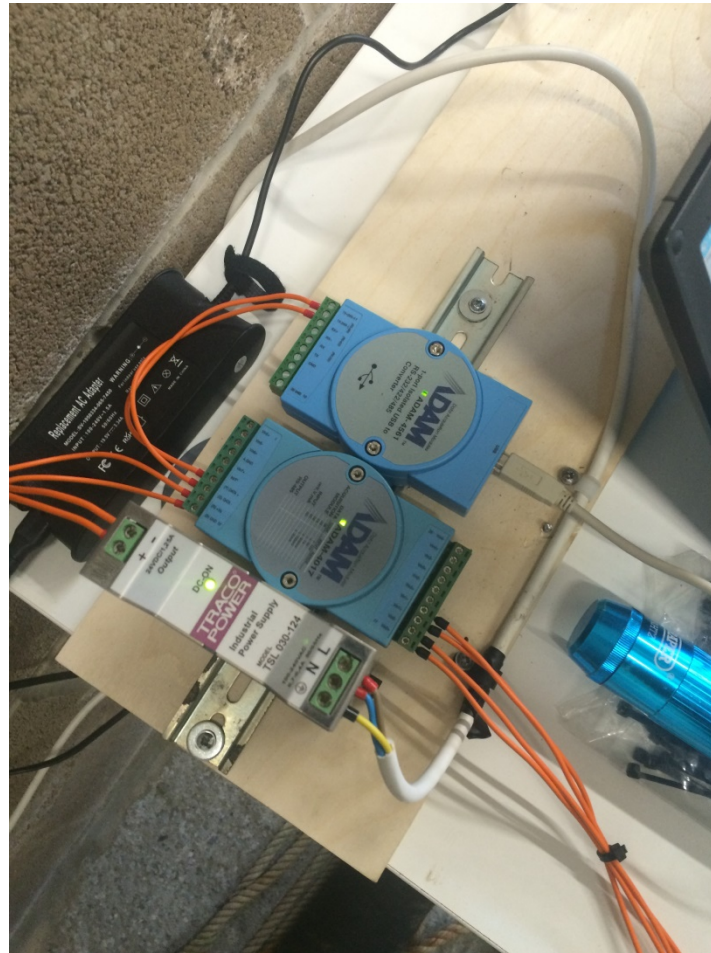
Measurement

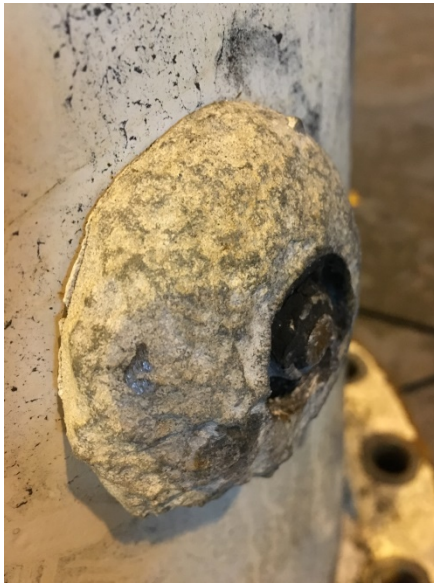
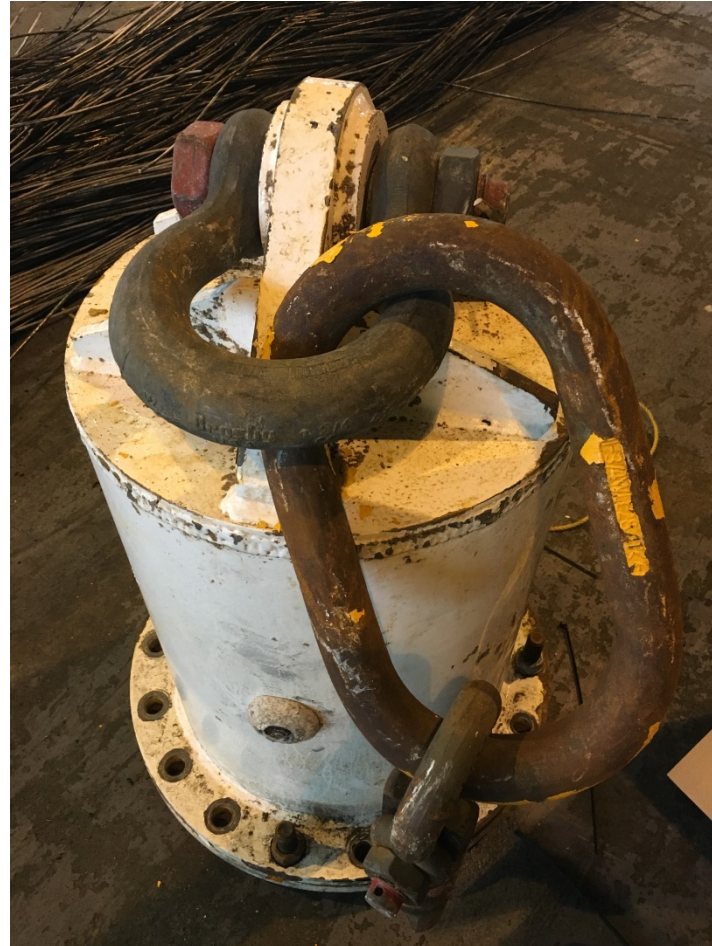
After 1 year

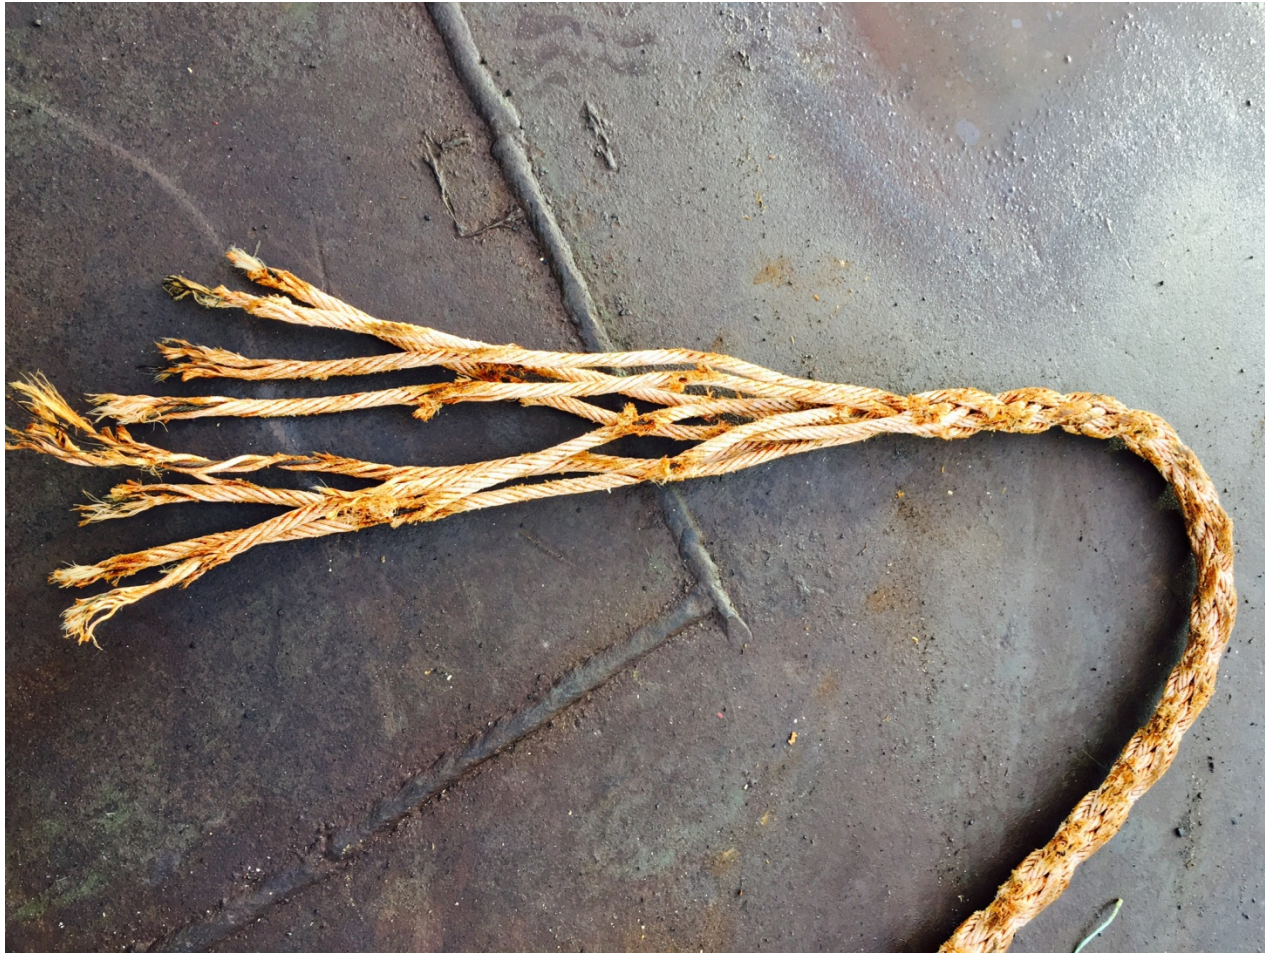
CATAC Condition – Deployment wire
