Subsea Corrosion Experiences

Material durability of Cables and Moorings

Jan Kenkhuis – Principal Engineer Mooring & Subsea

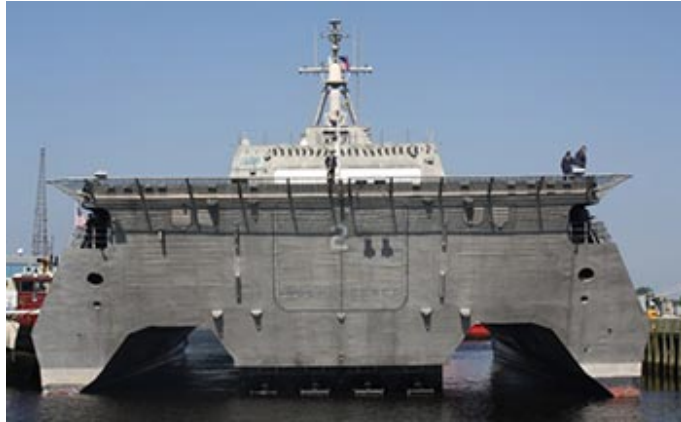
Story of the
US Navy Littoral Combat Ship
Aim Easy to Maintain over their lifespan

Ships were made of Aluminium with

- First ship suffered galvanic corrosion (2003)
- Second ship crack through the hull (2013)

Cause of Failure ---Design Flaws (2014)

- Corrosion concentrated in the ships propulsion system where steel impeller housing came in contact with the aluminium vessel (Nov 2013)
- The specification lacked the requirement for a Cathodic protection system
- 2 dissimilar metals come into electrical contact
- Electrical continuity not established

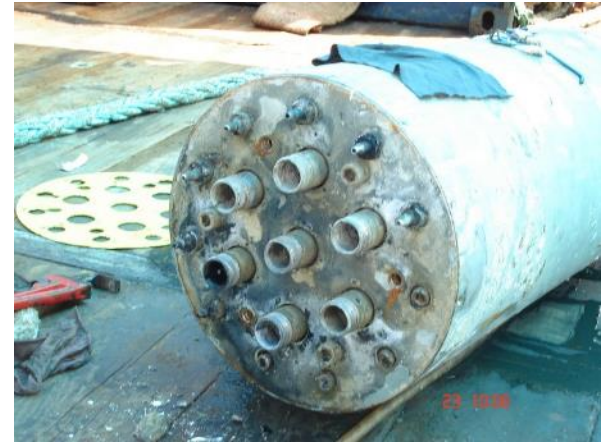
At time of repair in 2009

Cause of the rapid corrosion

- No electrical continuity guaranteed between connectors and bulkhead plate.
- Connectors supplied from 1.4418 stainless grade. Equals to 304 grade
- The specification asked for 316L grade
- Concerns raised about the uncertainty of the isolation between SUTU and PLEM

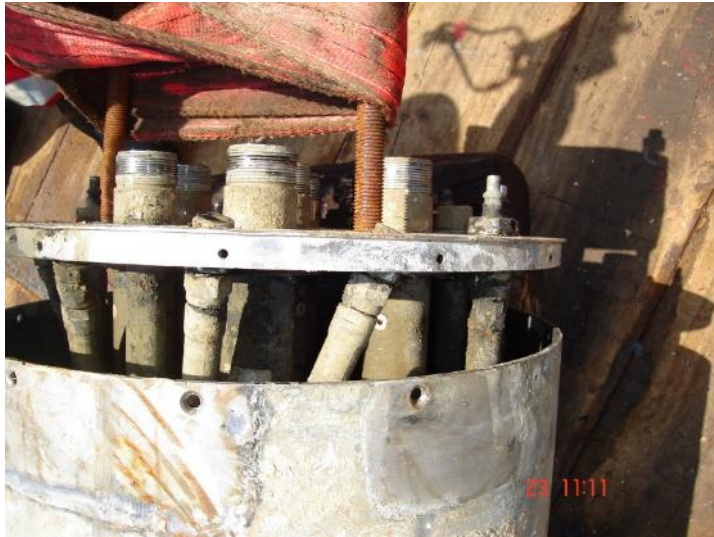
Open SUTU

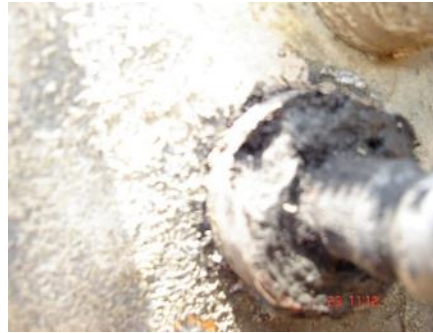
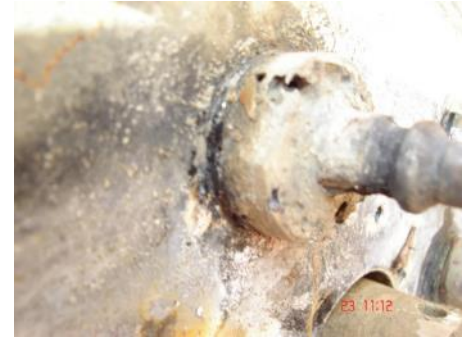
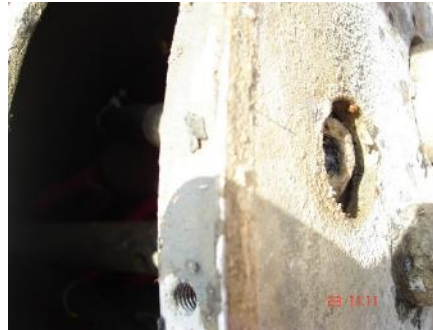
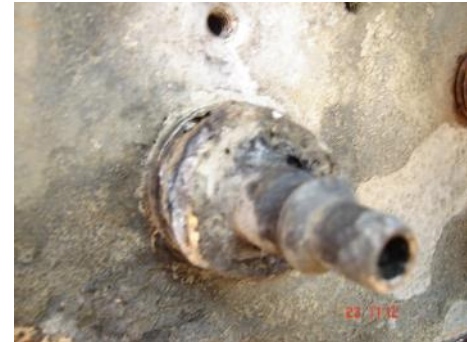
Hydraulic connectors

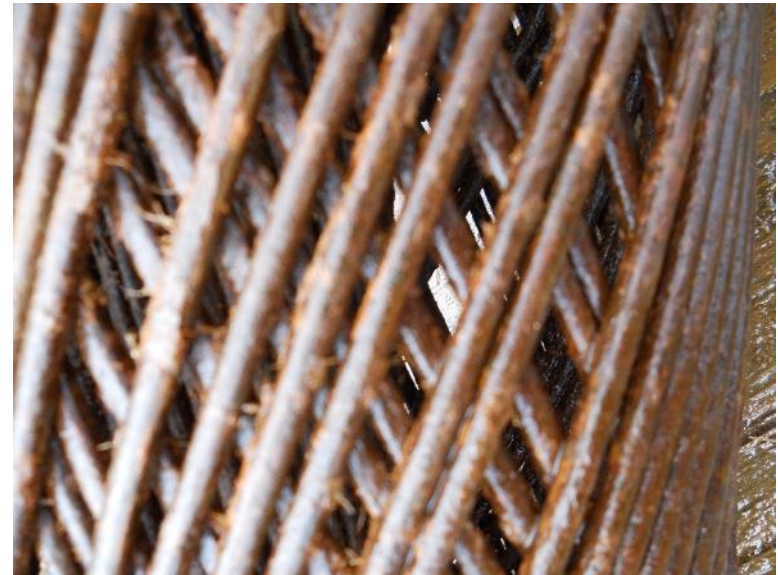
close up picture

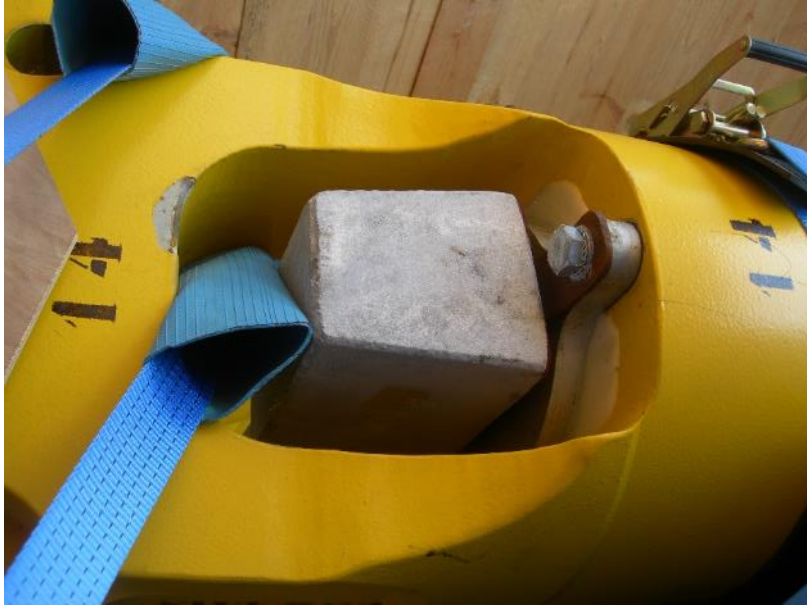
Anode new

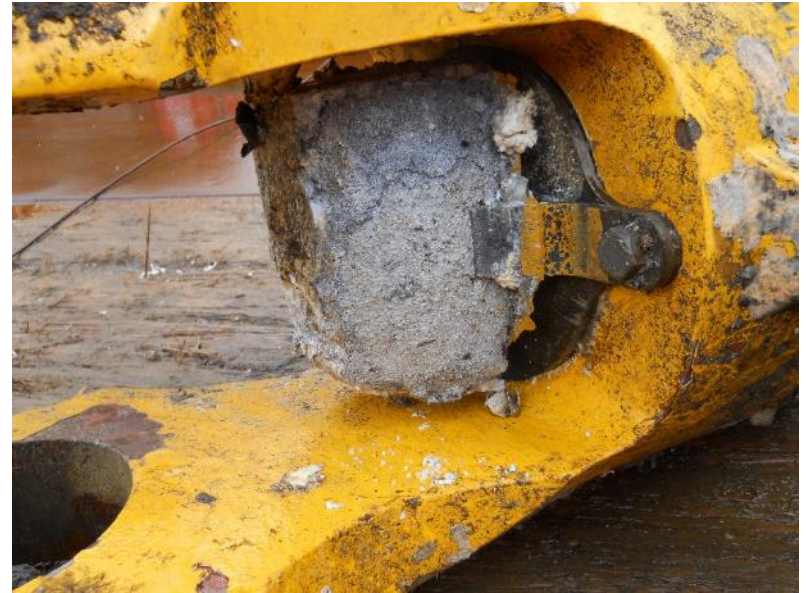
Anode after 5 years

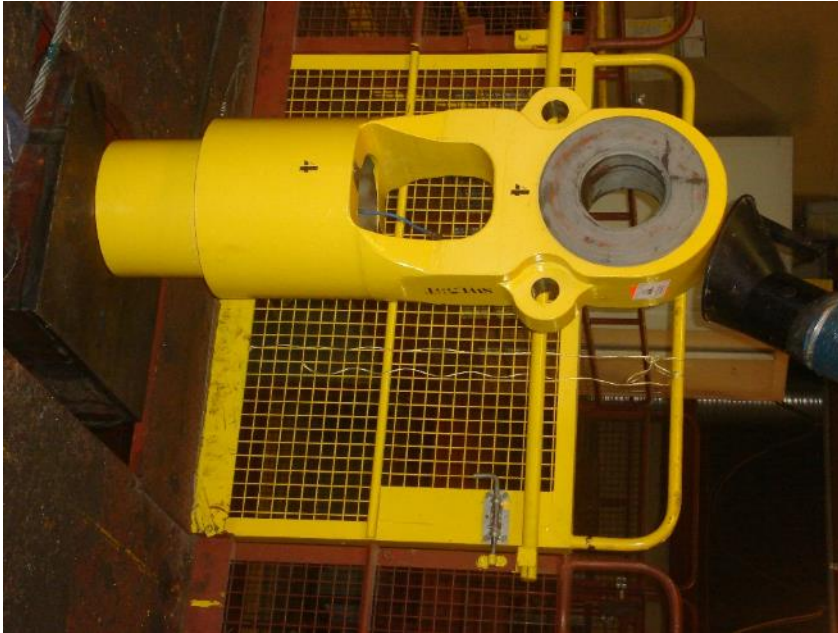
Orkot bushes to achieve
electrical discontinuity

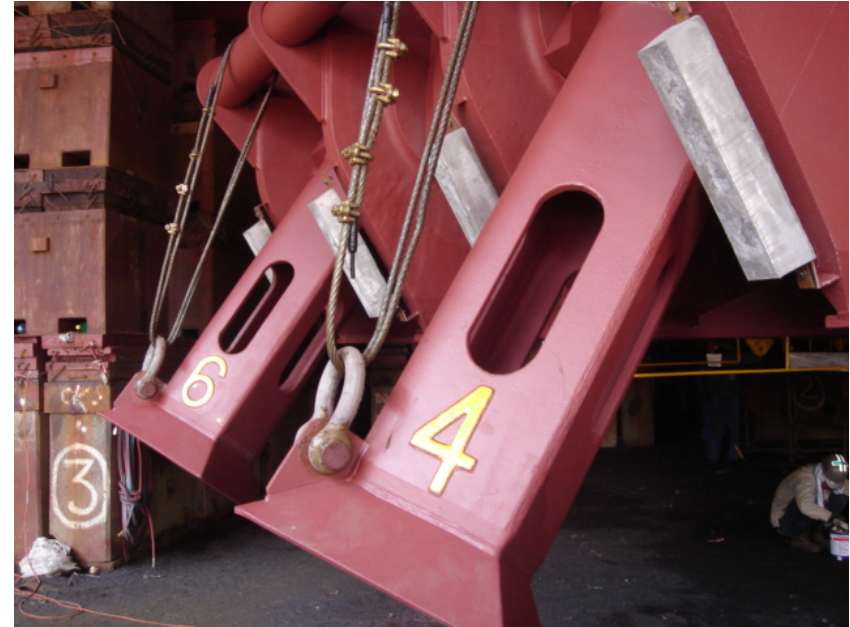
chain stoppers
with CP system

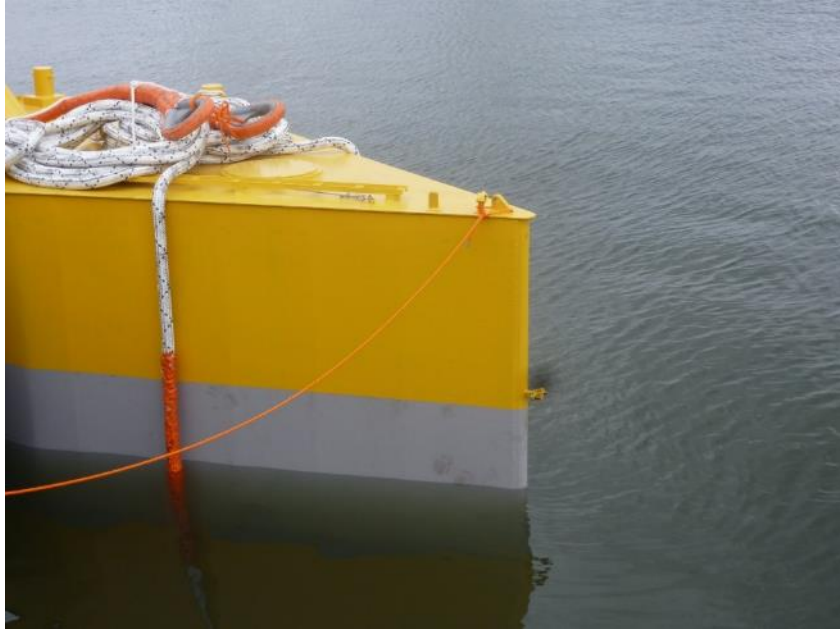
Mooring Lines: prior installation

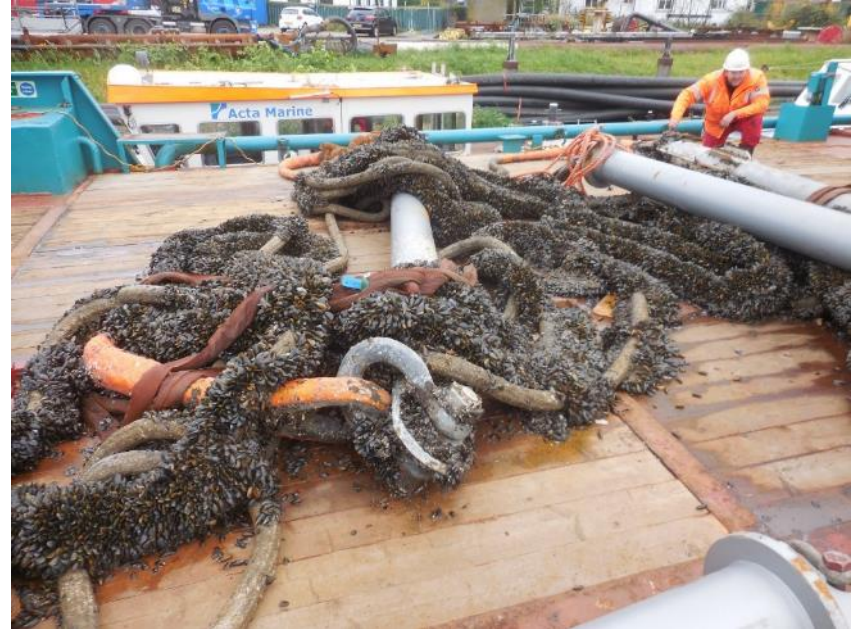
Mooring Lines: after 0.5 years

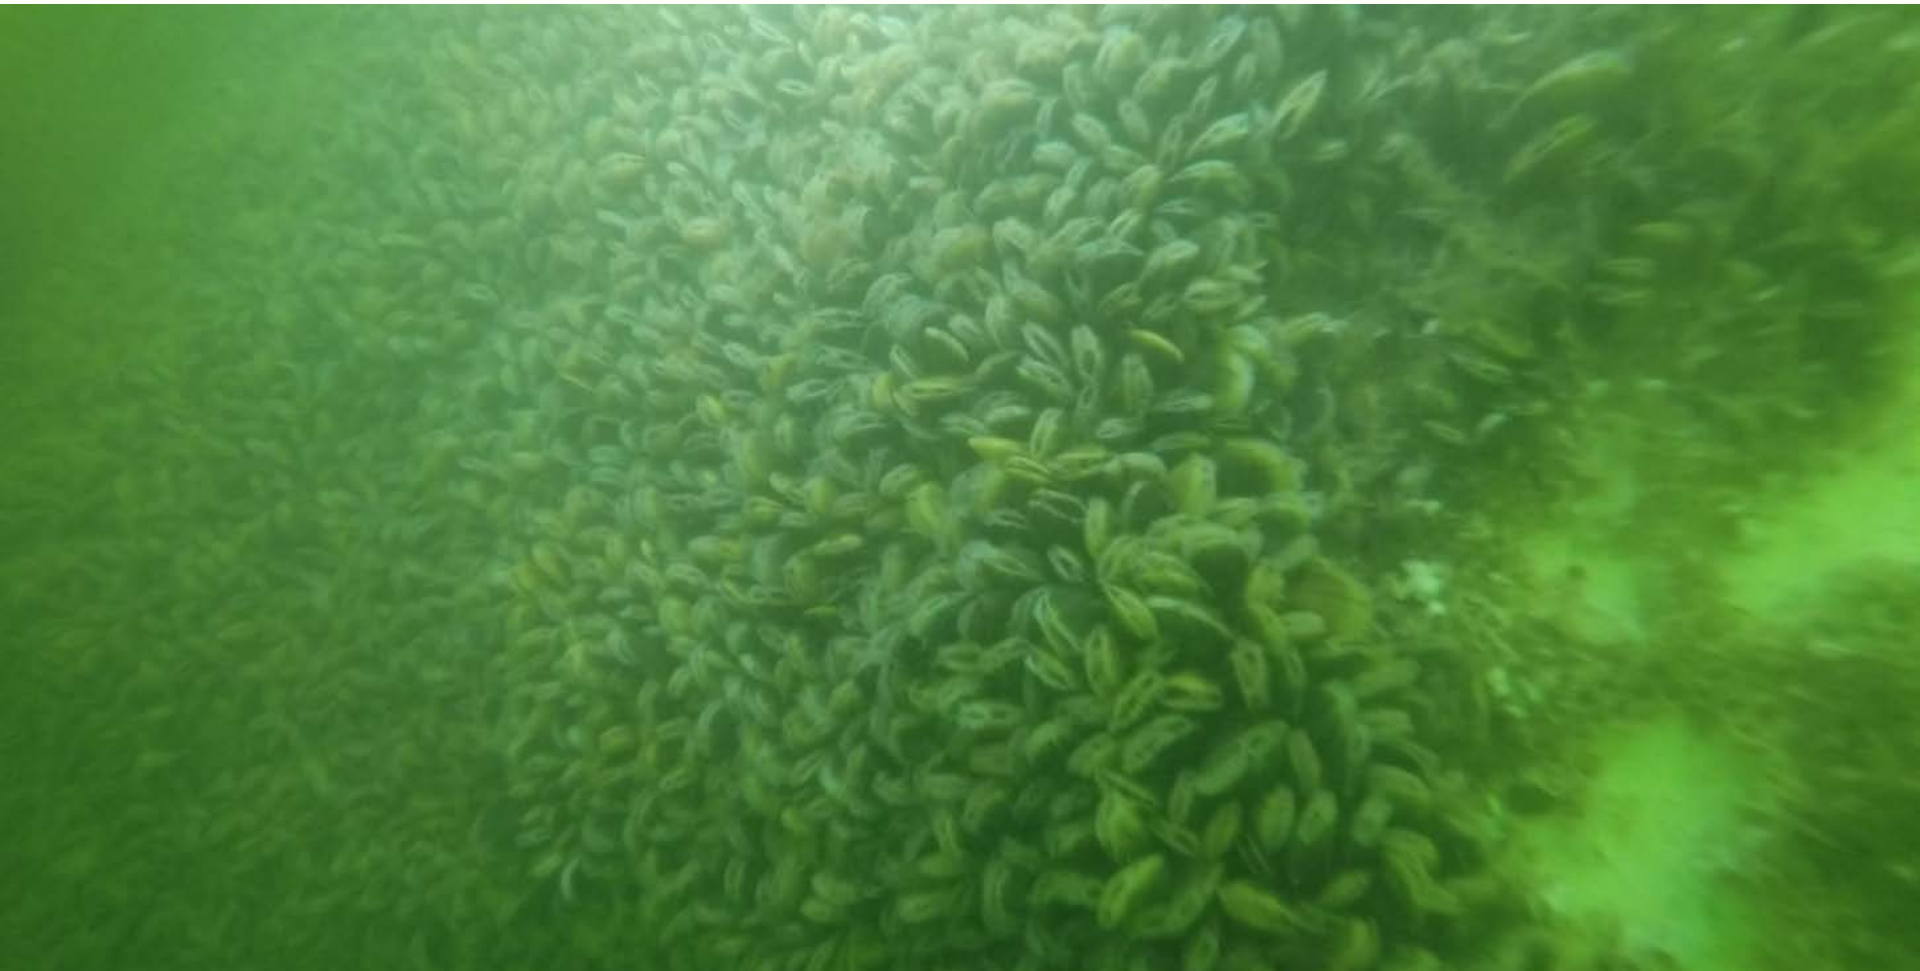
BTT underwater, non-coated

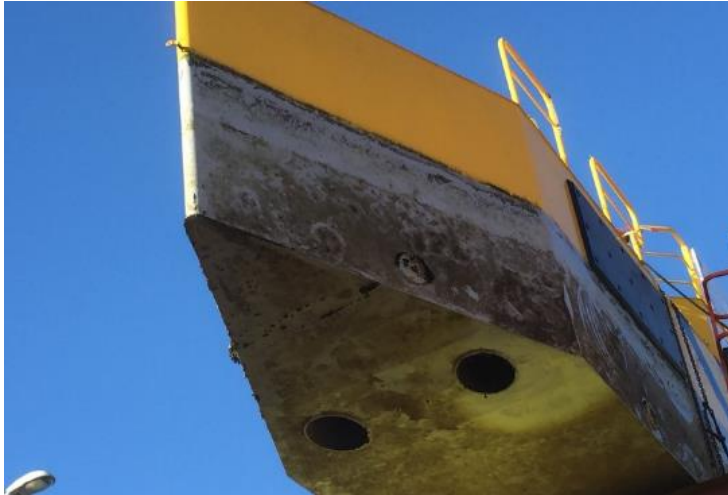
BTT floater out of the water

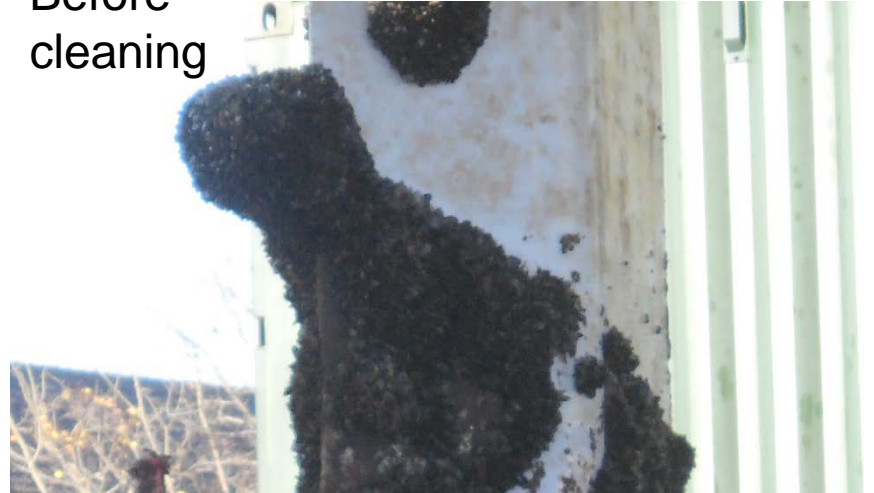
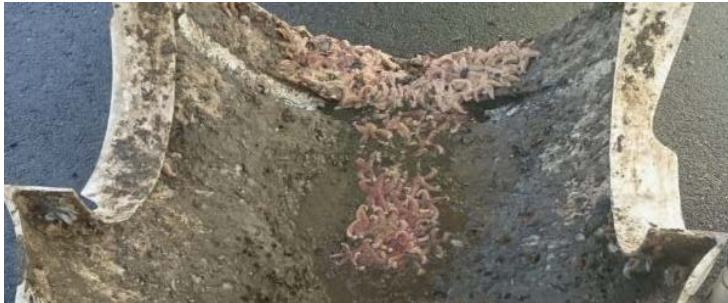
Before
cleaning

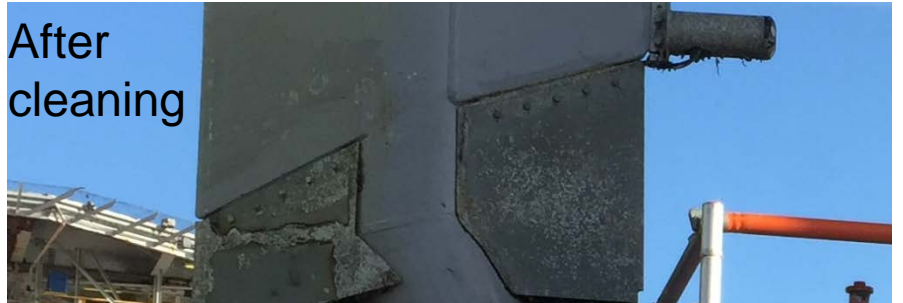
After
cleaning
