# Experience of Degradation of Mooring Systems used in the

# Mooring Component Failure

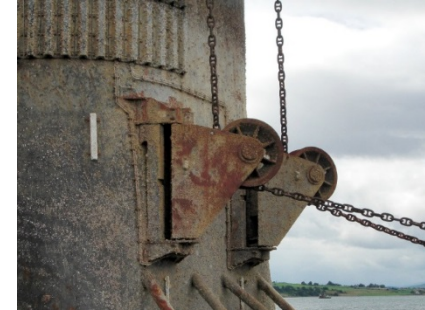
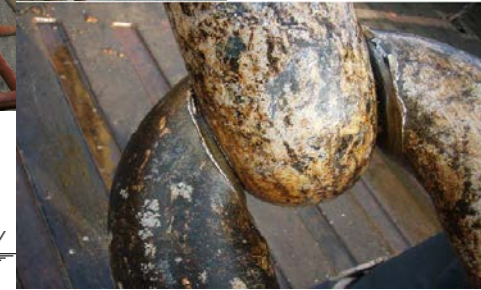
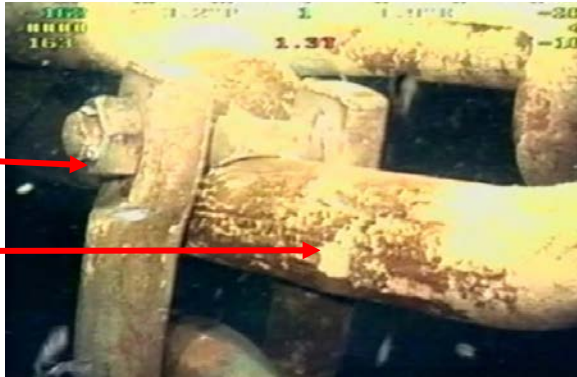
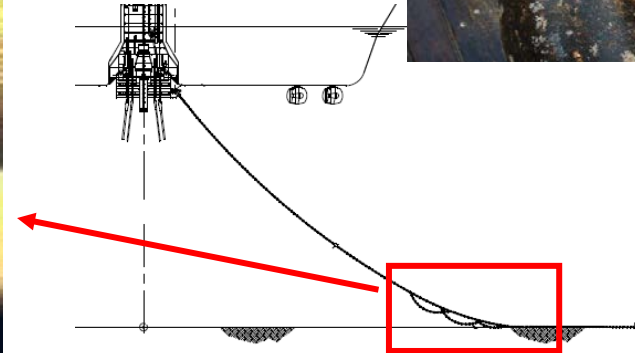
- Wear rate highest where there high tension and relative motion; relative motion dominates
- Reduce relative motion → reduce the wear
- However, it's unlikely that any of these factors are unique to the Minas Passage

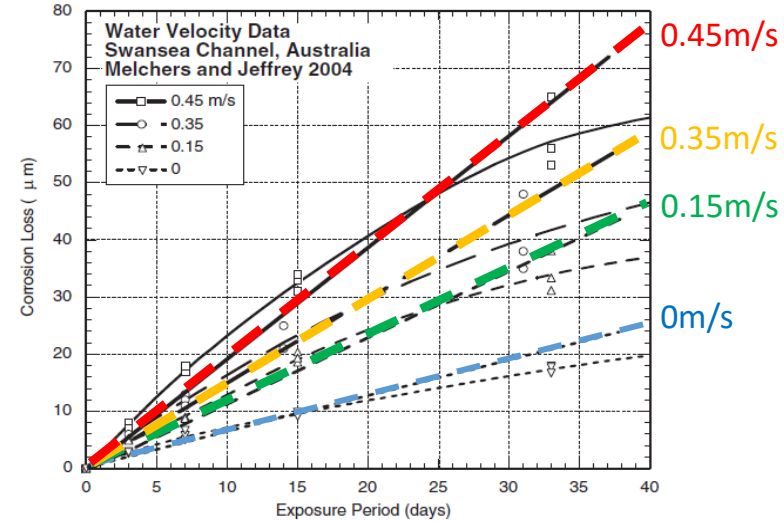
- Water Temperature?
  - Pretty typical of other environments without low corrosion rates
- Dissolved Oxygen?
  - Any evidence of this being higher than typical levels at similar water depths?
- Microbiological Corrosion?
  - High nutrient levels from agricultural run-off could be a factor
  - More typical of warm water environments; Aerobic corrosion layer must build up to create anaerobic environment
- Water Flow Rate
  - Phase 1 corrosion rate increases dramatically with flow rate
  - Note: test shown only goes up to 0.45m/s
    - Peak Tidal current at Cape Sharp is 5.5m/s

Average water temperature of 20-deg C; higher than Bay of Fundy, but relationship between flow rate and corrosion rate remains the same.

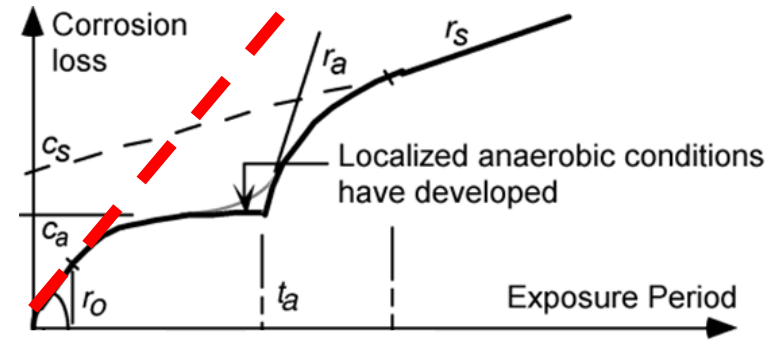
- High flow rate is leads to high initial corrosion rate, and
- Oxide layer needed to slow the corrosion rate does not establish due to abrasion:
  - Between mooring components,
  - Between components and seabed,
  - Abrasion due to entrained sand in flow?
- Components continually remaining in the Phase 1 high aerobic corrosion phase

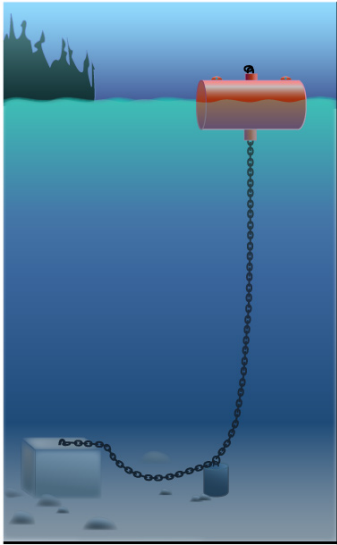
Single line  
Low pretension  
High relative motion

- Reduce motion between mooring components to reduce wear
